Inspection Report

Address: Anytown, New Jersey

Date: October 12, 2022

Total Home Inspection Services, LLC
170 Kitchell Lk Dr West Milford, NJ 07480
Phone: 201 406 5213
office@thisinspection.com

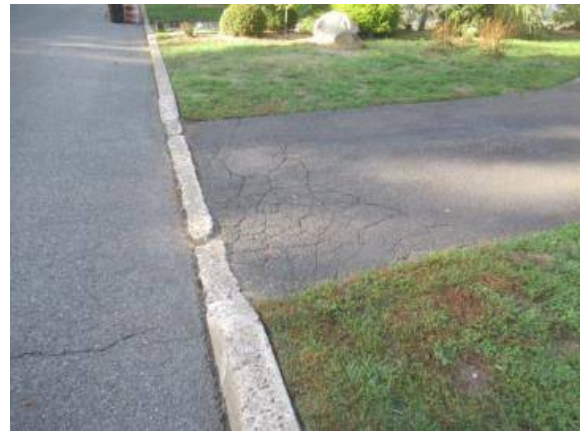
- Driveway Condition:** **Attention Recommended-** The driveway needs repair to cracked/worn areas to prevent further wear/deterioration.

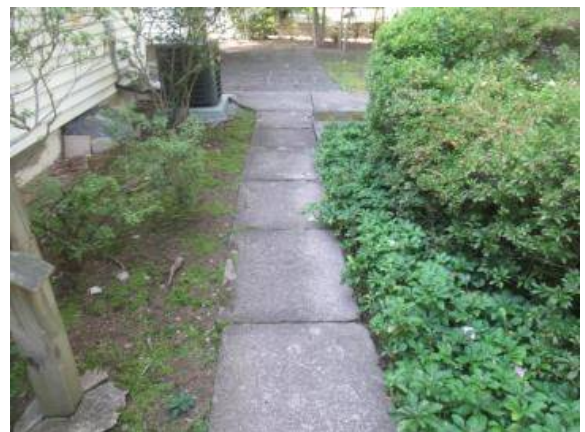
Attention Recommended- The rear walk is uneven/worn. Relevel/repair where needed.

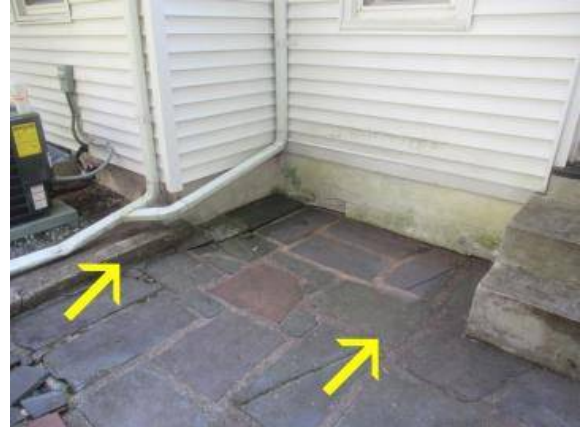
Patio Condition: **Attention Recommended-** The patio is settled and backpitched and drains surface water toward the structure. Relevel/replace the patio to provide proper drainage.

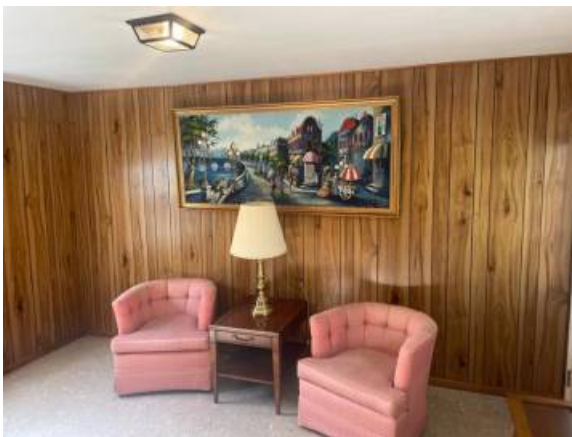
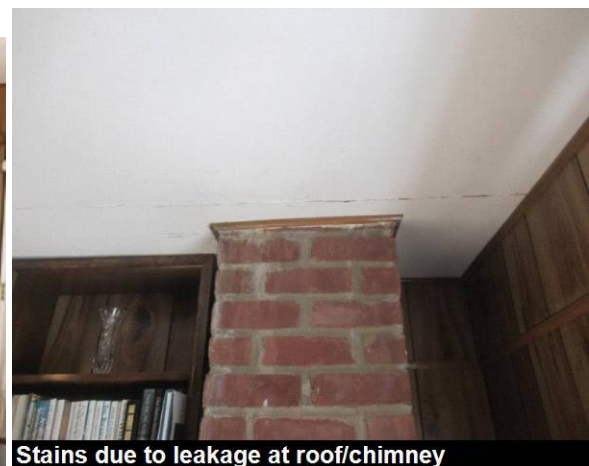
Condition of Porch: **Action Needed-** There are stains at the ceiling due to prior leakage at the chimney. Expect repair.

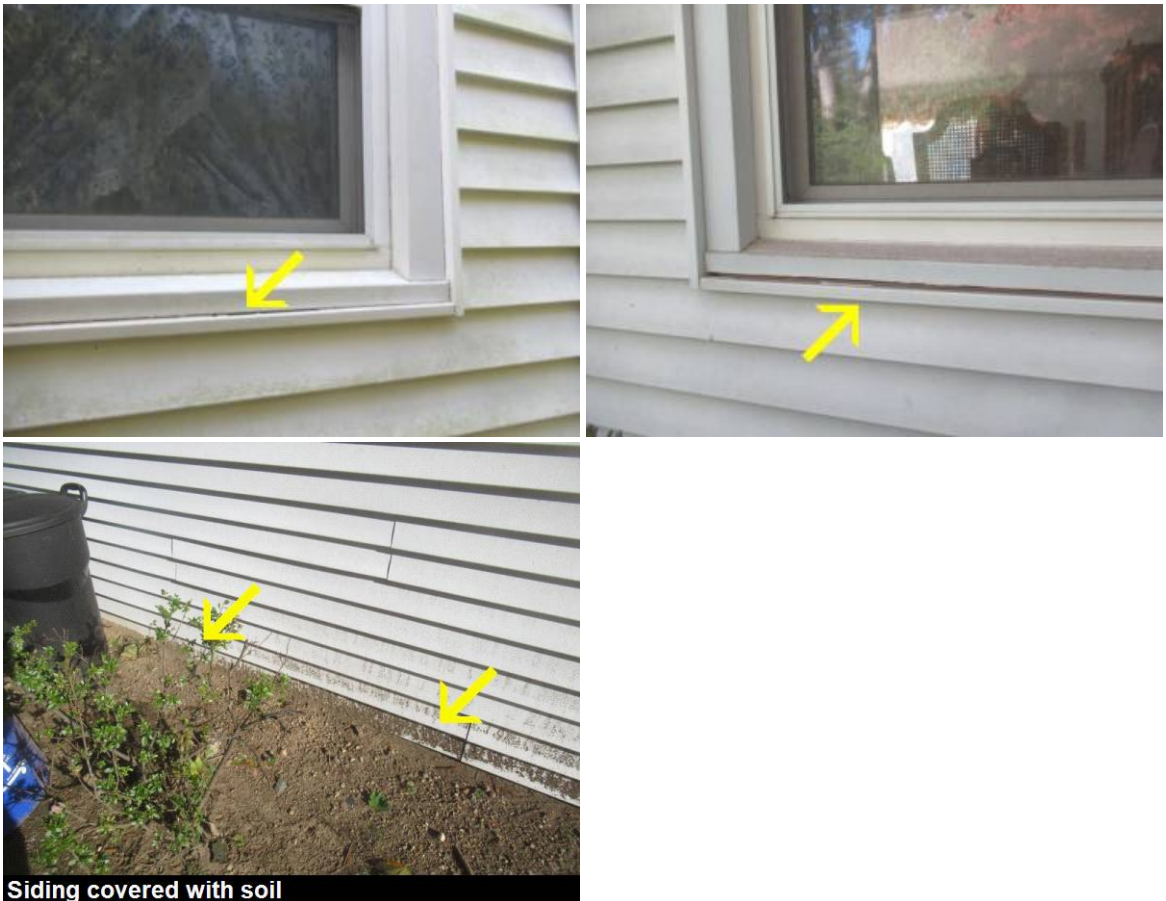
Attention Recommended- The siding is in direct contact with soil. This can allow moisture to damage the wood behind the siding. Also, this condition is conducive to wood destroying insect infestation. Further evaluation behind the siding materials will determine the condition of the framing and sheathing. This evaluation should be completed prior to closing

Alter the soil/grading to correct this condition. There should be adequate clearance to soil at the base of the siding. Consider a preventive wood destroying insect treatment and/or a pest control policy for annual inspection.

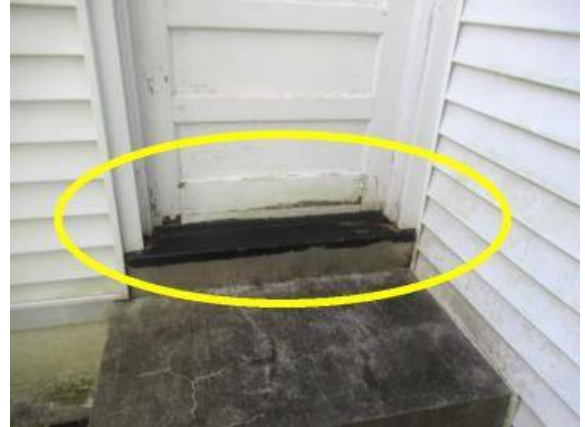
Exterior Doors: **Attention Recommended-**Some of the original doors and sills are damaged.

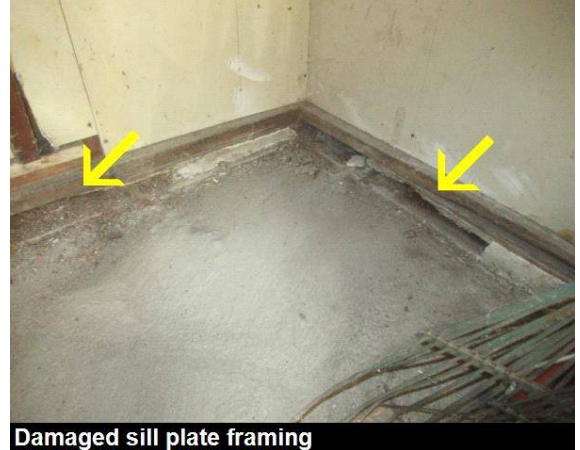
Action Needed- There is damaged sill plate framing in the garage. Further evaluation by a qualified contractor is recommended to determine the extent of repair needed at this time. The evaluation should be completed prior to the expiration of your inspection contingency.

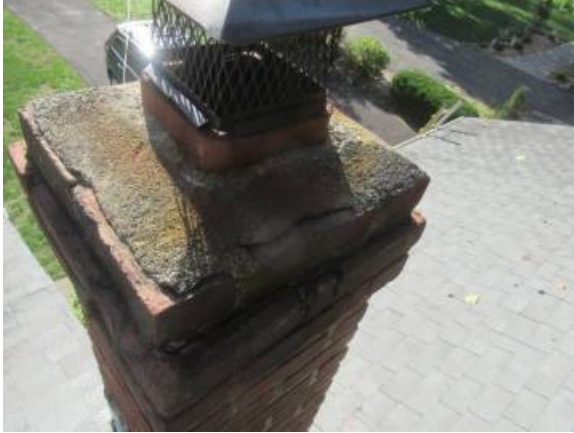
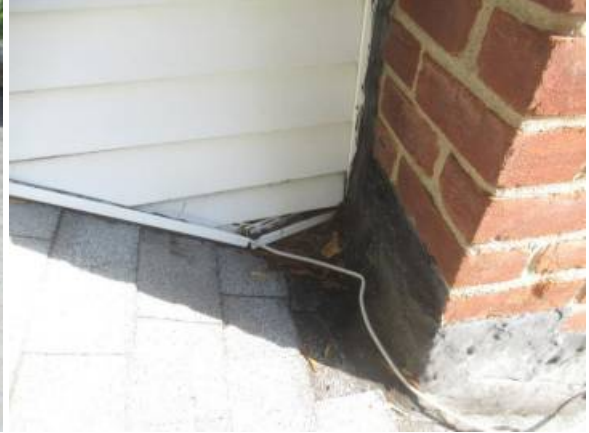
Chimney Condition: **Attention Recommended-** The masonry chimney top crown area is cracked and worn and there are cracked joints at the bricks, which will allow for water penetration into the chimney. Repair by a chimney professional is necessary.

Please Note- The masonry chimney flashing is coated with tar/roof cement, apparently to correct previous leakage. The tar will dry and crack and is not a long term repair. Monitor and expect to repair/reseal the flashing.

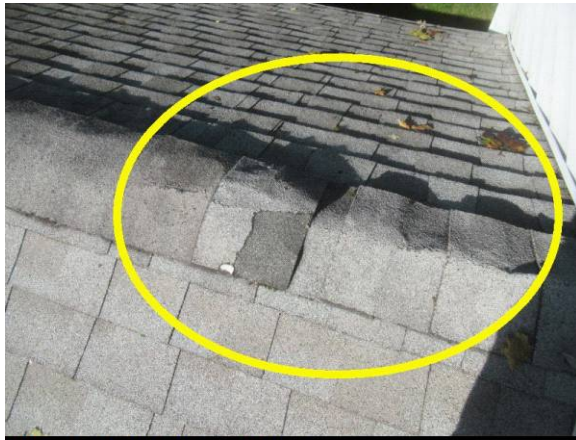
Condition of Roof: **Action Needed-** The damaged ridge shingles should be replaced and the attic fan cover replaced to prevent leakage.

Damaged shingles at ridge

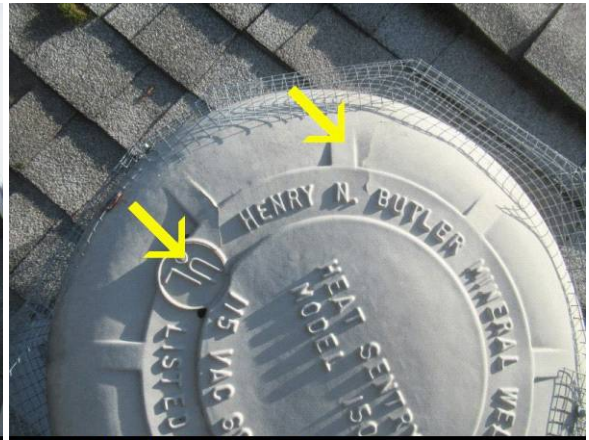
Cracks and holes in cover

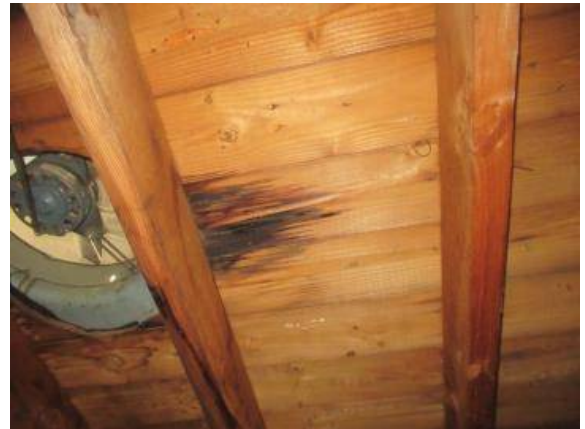
Action Needed- There is water staining due to roof leakage. Unless there is documentation of a repair, the leakage should be considered active. Repair is needed. The stains are located at the attic fan and sunroom.

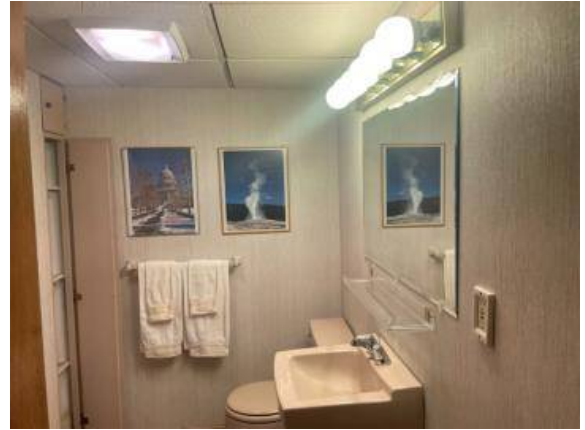
Walls/Ceiling: **Action Needed-** The walls are damaged and there is a possible mold type growth.

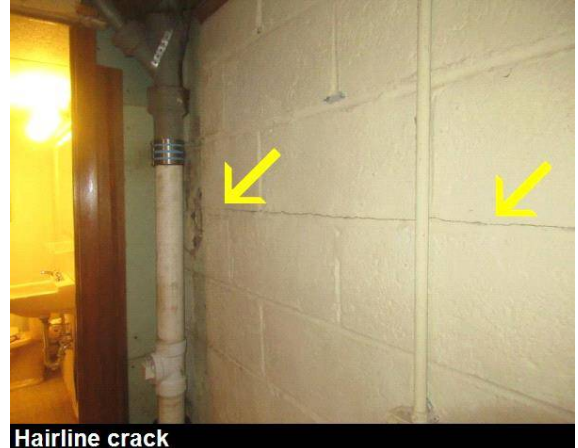
Attention Recommended- There are hairline horizontal cracks noted at the interior foundation. These cracks are not considered to be a structural concern at this time. Seal the cracks to monitor for movement and to guard against water infiltration.

Hairline crack

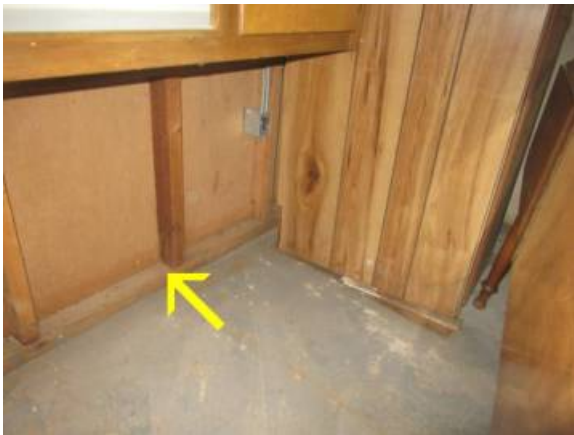
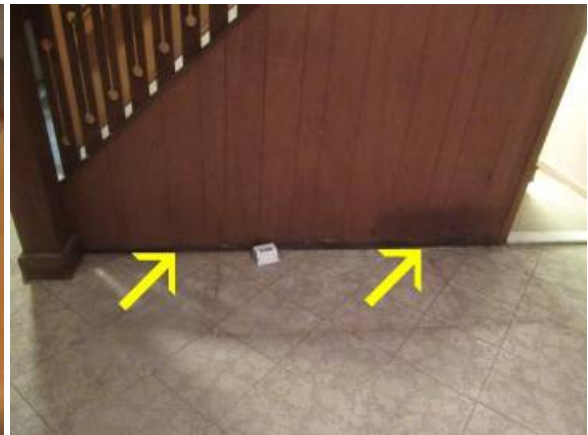
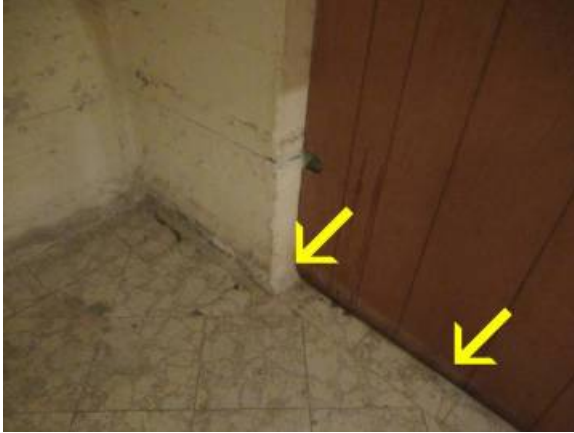
Action Needed- There is evidence of a chronic water seepage condition as indicated by stains/efflorescence on the basement walls/floor. Installing some type of interior waterproofing system is needed to completely control water seepage. A waterproofing contractor can provide details and cost for the type of system.

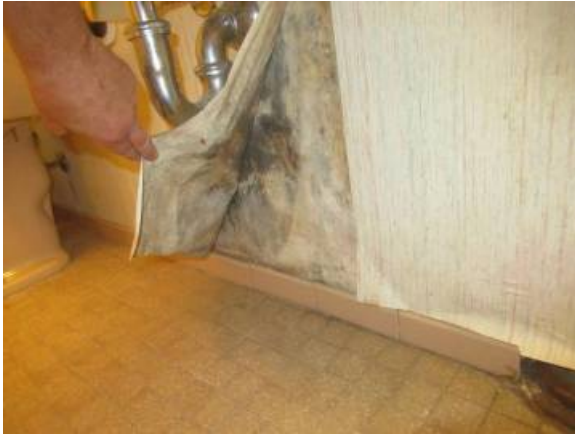
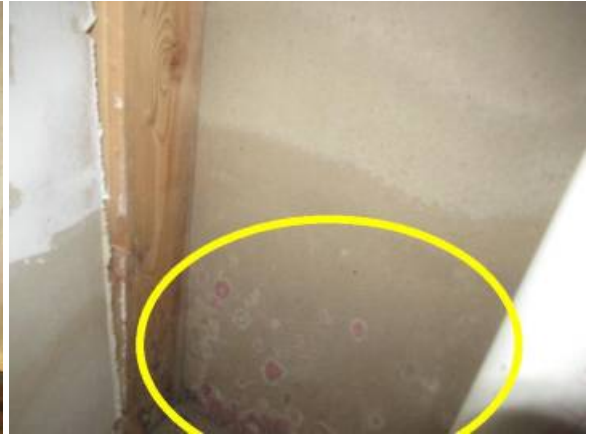
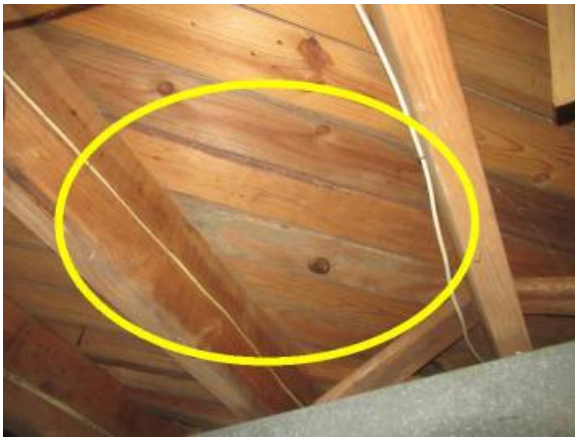
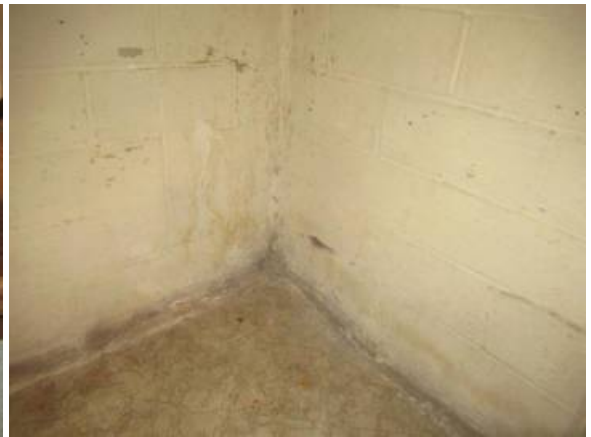
Action Needed- There is a possible/suspect type of mold type of growth in the basement bathroom and on basement foundation and wood subflooring/ceiling. There is a possibility that additional areas are affected that are not visible/accessible. Contact a remediation contractor to remove the growth, prior to closing, to determine the extent of mold growth. Since there could be mold in other areas of the house, a full mold inspection of the entire house by a qualified company is recommended. This could include surface sampling and air testing.

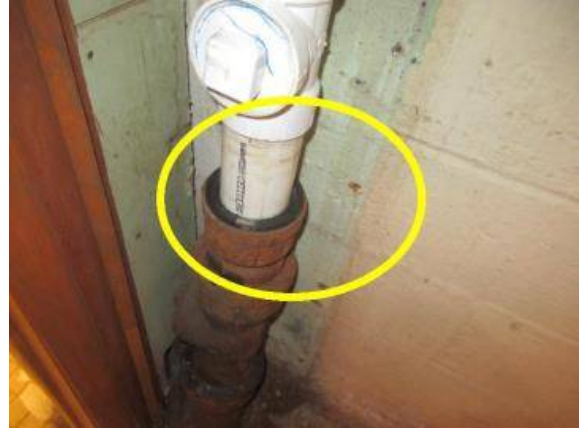
Action Needed- There is active leakage at the PVC piping transition to the original cast iron. Repair should be completed by a plumbing contractor.

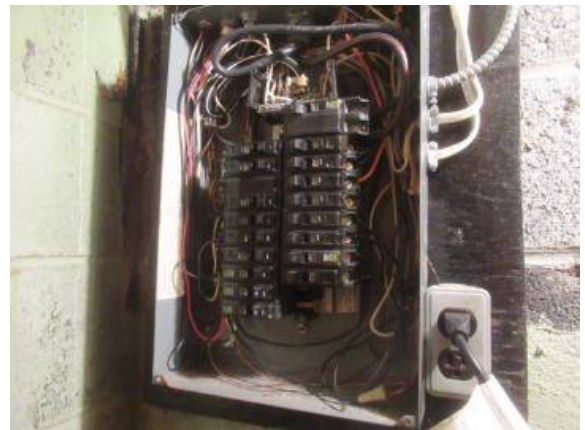
Main Panel Condition: **Attention Recommended-** There is inadequate access at the main panel box due to the location of the wall. Clearance of 36 " in front of the panel box and 30" side-to-side total width is required.

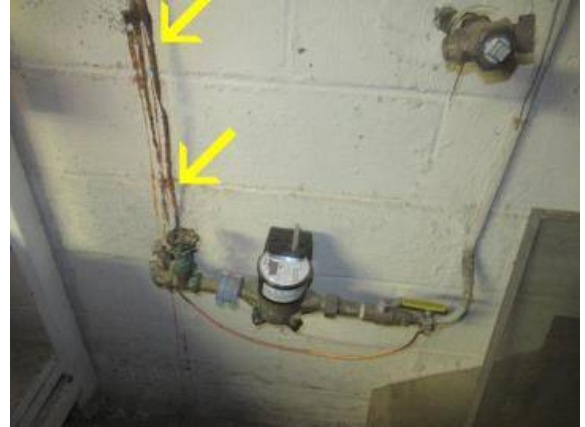
Action Necessary- There is rust/corrosion at the main ground cable connection to the water service pipe. The grounding cable should be replaced.

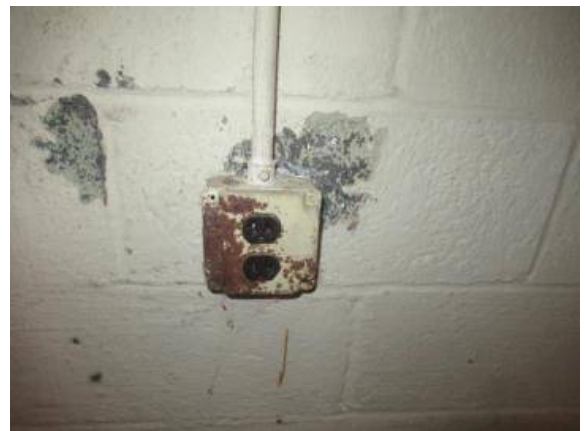
Circuit Wiring Condition: **Attention Recommended-** Some metal outlet boxes in the basement are rusted. Replacement is recommended.

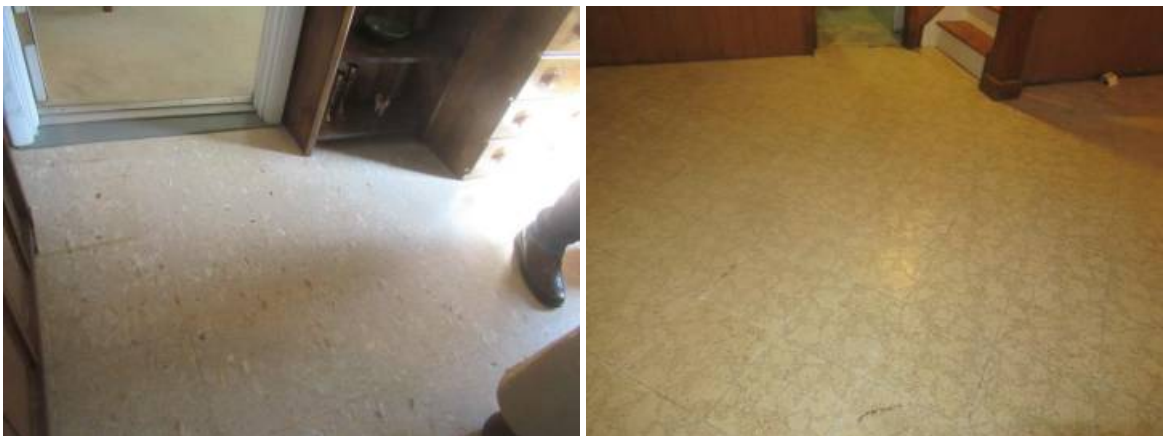
Please Note- There are 9 X 9 and 12x12 floor tiles observed. Asbestos has been used in most 9 X 9 tiles and in some of the mastics used to glue the floor tiles down. The only way to tell for sure if something contains asbestos is to have it analyzed by a laboratory accredited to do this type of analysis. Flooring that contains asbestos, when in good condition and intact, is generally considered nonfriable and not hazardous, according the NJ Dept of Health. If the tile is to be removed, an asbestos remediation contractor should be consulted. Flooring installers usually will require removal prior to installing new flooring over the tiles.
