Inspection Report

Address: Anytown, New Jersey

Date: October 12, 2022

Total Home Inspection Services, LLC
170 Kitchell Lk Dr West Milford, NJ 07480
Phone: 201 406 5213
office@thisinspection.com

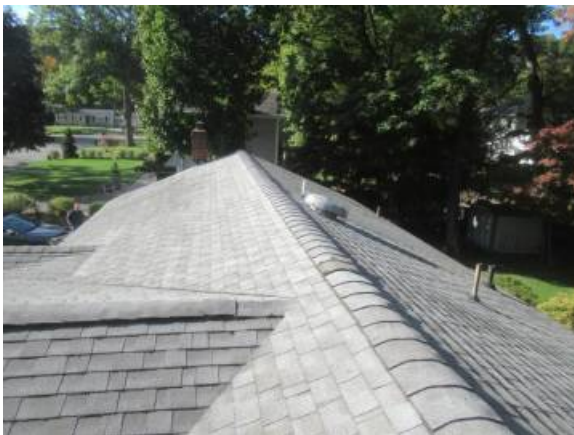
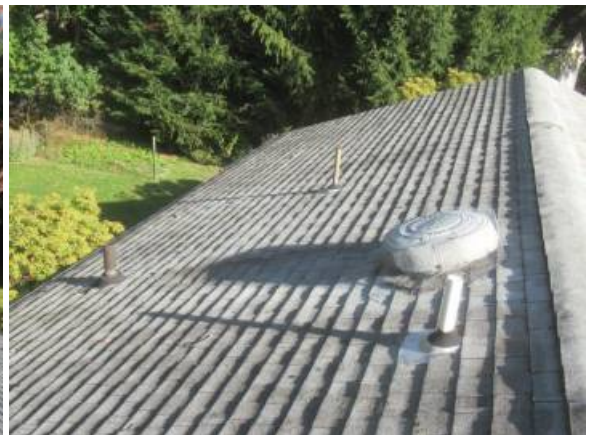
Condition of Roof: **Action Needed-** The damaged ridge shingles should be replaced and the attic fan cover replaced to prevent leakage.

Attention Recommended - The roof shows signs of wear/age and is nearing the end of its life expectancy. Expect stepped up maintenance/repair to prevent leakage over the short

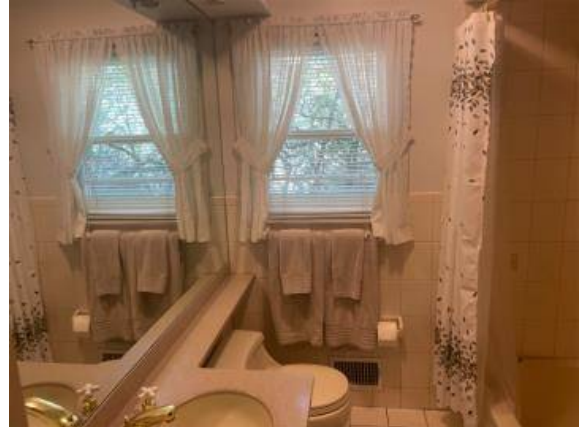
Location: First Floor

Entry Door:	Acceptable- The bathroom door is acceptable/functional.
Walls/Ceiling:	There is staining at the ceiling due to prior leakage. The stains were dry at the time of the inspection. Monitor for leakage and repair as necessary.
Floor:	Acceptable- The bathroom floor is in acceptable condition.
Window(s):	Acceptable- The bathroom window is in acceptable condition.
Ventilation Fan:	Acceptable- The exhaust fan is functional.
Light Fixtures:	Acceptable- The light fixtures are functional.
Outlet(s):	Acceptable- The outlets tested are in acceptable condition. The outlet(s) is Ground Fault Circuit Interrupter (GFCI) protected and is functioning properly. This type of safety device helps to protect against an electrical shock hazard.
Water Flow/Drainage:	Action Needed- Drainage at the bathroom sink is poor; drain line cleaning/repair is needed.
Toilet:	Acceptable- The toilet is operated a few times and is functional with no sign of leakage from the tank or at the base.

Bathtub/Shower Fixtures:	Acceptable- The bathtub faucets and drain stopper are in acceptable condition. The overflow drain is not tested for proper function. Since these can leak, try to avoid filling the tub with water up to the overflow drain.
Bathtub/Shower Walls:	Acceptable- The bathtub/shower tile walls are in acceptable condition with no loose tiles noted. Recaulking at wall joints is part of normal maintenance to guard against water leakage behind the tile.
Caulking:	Attention Recommended- The caulking in the water contact areas needs attention to guard against water leakage behind the tile. The bathtub/wall joint should be recaulked.

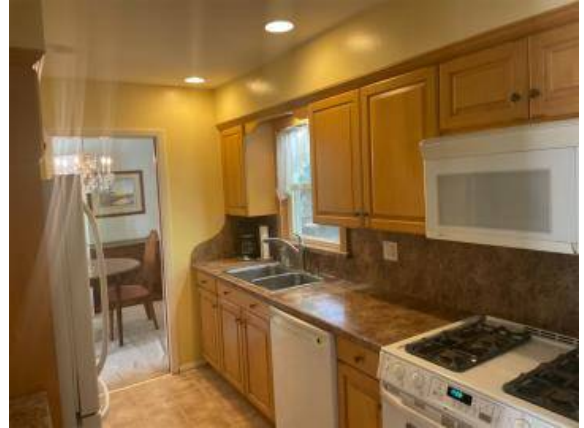
- Floor:** **Attention Recommended-** The flooring in the kitchen is worn.
- Switches/Outlets:** Acceptable - The outlets tested in the kitchen are acceptable and the Ground Fault Circuit Interrupter (GFCI) devices functional.

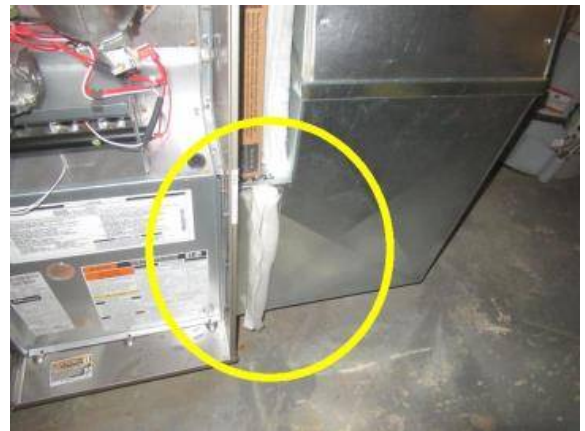
Humidifier:

Please Note- The water supply is turned off for the humidifier unit. The humidifier can't be tested. These units typically require annual maintenance and parts replacement.

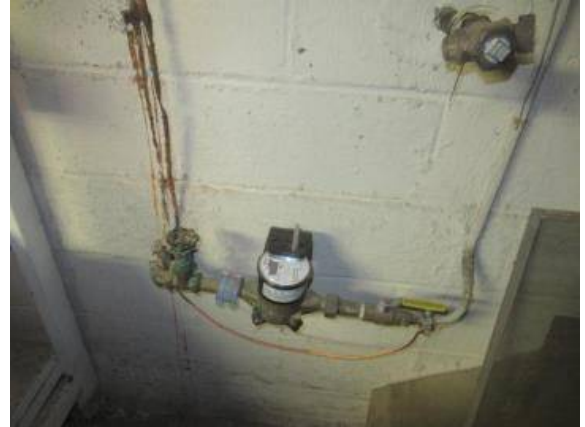
Please Note- One of the main water shut off valve is old, and might be difficult to close or could leak when operated. Expect to install a new valve.

Please Note- There is no pressure regulating valve at the main water supply. Installing a pressure reducing valve will provide protection in the event of excessive pressure. This type of valve is typically installed with an expansion tank.

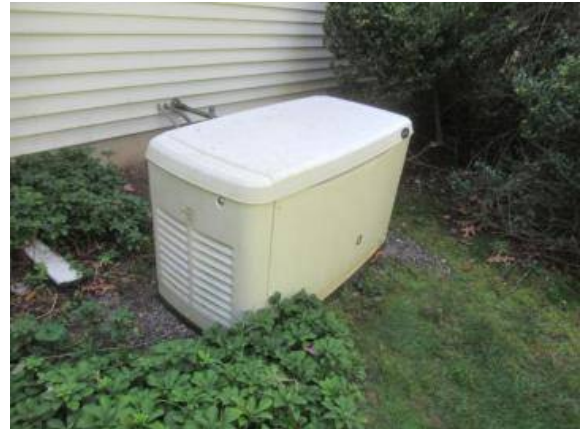
Generator System: **Please Note-** The automatic standby generator system is not inspected or operated. Ascertain from the owner whether a permit was obtained for installation. This specialized equipment should be serviced regularly and should be Inspected by a service technician prior to closing.
